6.0 Grand Junction, Colorado, Disposal Site

Figure 6-1. 2003 Annual Compliance Drawing for the Grand Junction, Colorado, Disposal Site

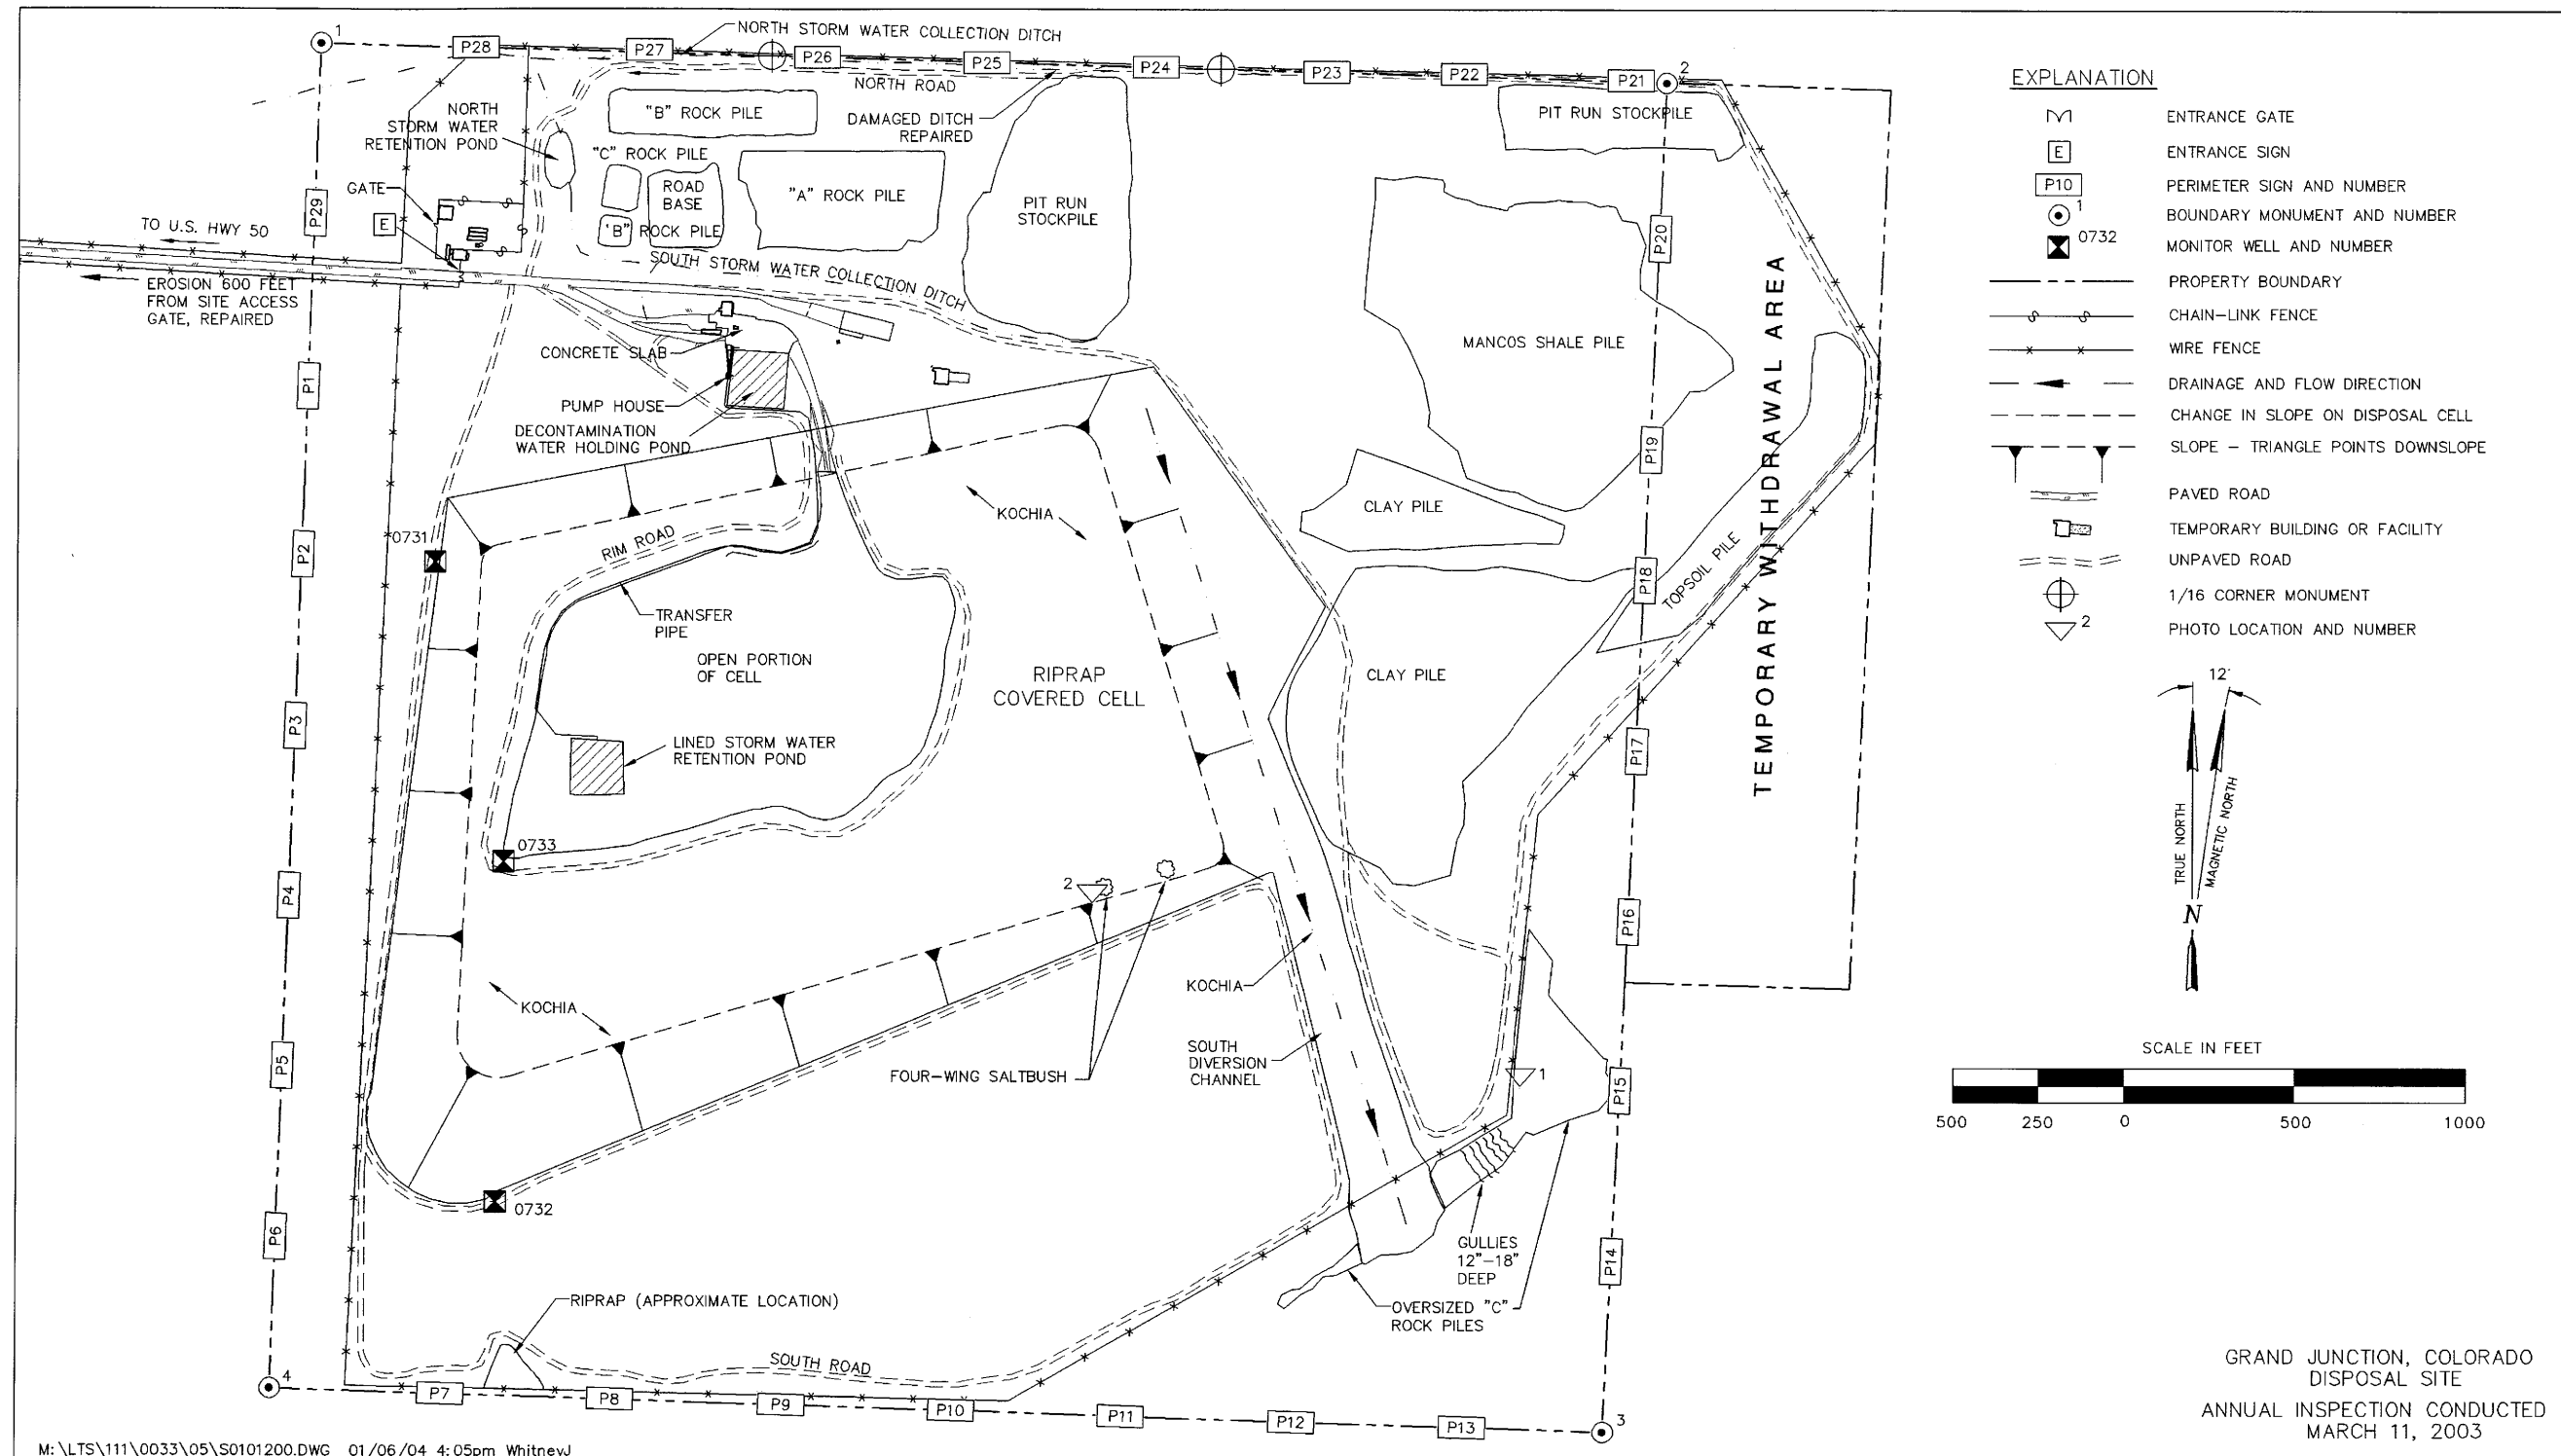
6B Minimal plant encroachment was observed on the side slopes. However, plant encroachment is occurring on the cell top, mostly on the southeastern part of the cell (PL-2). Deep-rooted plants, which were cut back and treated with herbicide in 2001, may change the performance characteristics of the radon/infiltration barrier. An investigation is underway by DOE to evaluate whether or not the deep-rooted vegetation needs to be controlled. Until the evaluation is completed, these plants will be controlled.

6C The north storm water collection ditch captures runoff from a large catchment area north and east of the disposal site. Water captured in this ditch flows into a large natural drainage north and west of the disposal cell. The north road crosses the north storm water collection ditch between perimeter signs P24 and P25. Tire ruts had caused water to leave the collection ditch and flow down the road. The ditch was reconstructed and the road was repaired in 2003.
